A Levantine Mansion: Buca Guidance Centre for Disabled Students

This study is based on two reports out of three prepared for the Restoration Project of a historical building, a Levantine mansion, Buca Guidance Centre for Disabled Students today, which was completed in February 2020. The first report is an elaborated descriptive analysis of the existing situation supported by a group of drawings and photographs. Second is the restoration report explaining renewal principles and what kind of repairment is considered space by space. Finally, the third is restitution report attempts to understand the phases in the building's history, the process of change until now. This article is the summary of the first and the third. Therefore, the data collection method is constituted of literature review, photographic documentation, and laser measurement. Naturally, depending on the measurements and photographs, a comprehensive data set with measured drawings including floor and ceiling plans, sections, elevations, and joint details, has been produced. The evaluation method is the comparative analysis to relate the common properties of Levantine houses with the plan typology and the traces in th

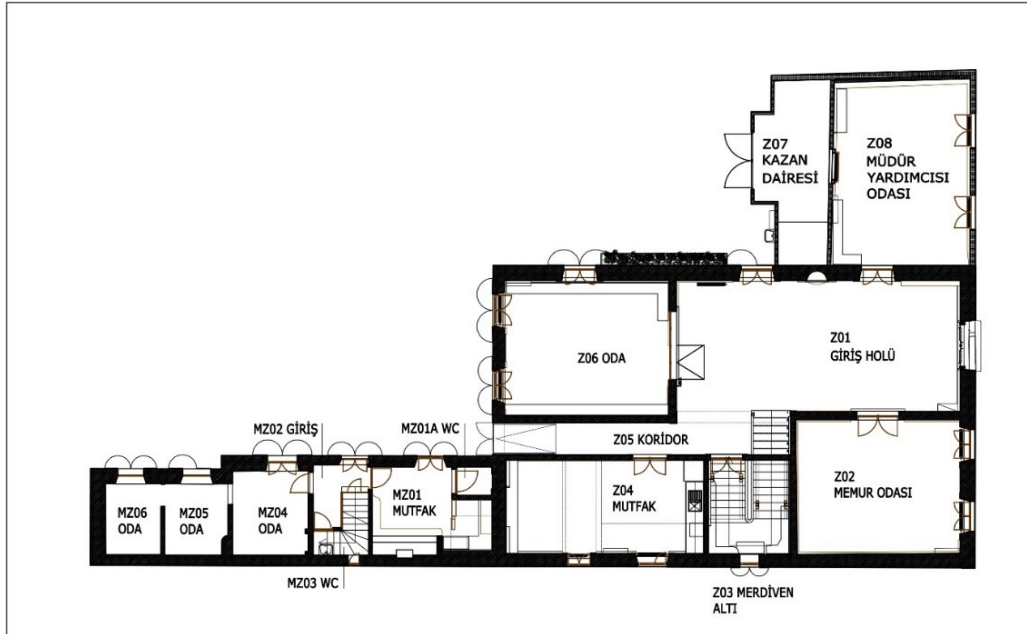
Figure 4. Ground floor plan of the measured drawings.

The floor is original and typical to Levantine houses as well, made up of marble, checkered with 60 by 60 cm. black and grey tiles and diagonally positioned. Gypsum mouldings on the ceiling, the gilded rose, grooved wooden jambs with heading and footing on the corners and the two wooden supporters with leaf figures at the stair side are the best of adornments in the mansion. Large grooved wooden jambs framing the niche and doors characterize the openings to rooms and garden. There are double-winged doors and shutters open to the side garden on the right wall of the entrance (Figure. 4). The walls and the ceiling are plastered and white painted.

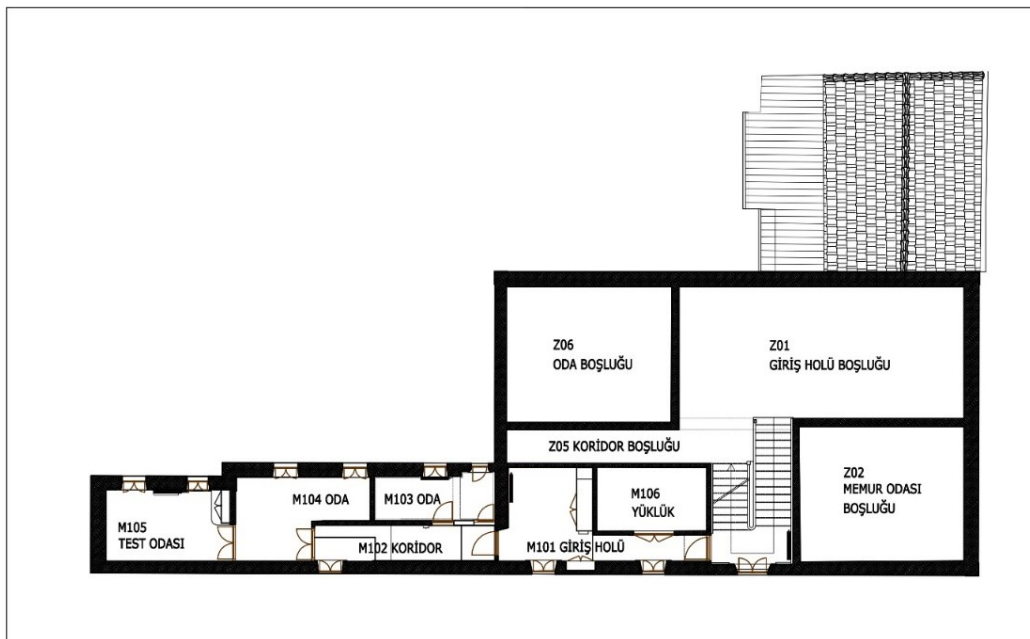
Figure 5. The second floor of the annexe is measured drawings.

The floor is of thick and large planks of wood (Figure. 5). The walls and the ceiling are plastered and painted. Two walls of the fixed cupboard area are coated with wood. There are one single-winged, four panelled wooden doors and two double-winged, two mullioned windows, and iron railings in the window openings. A three-winged wooden cupboard, of which one wing is fixed and the other two are with the hinges, so openable, and all are two panelled, is a simple but unique element. Likewise, the two panelled, double-winged, built-in cupboard is peculiar to the mansion.

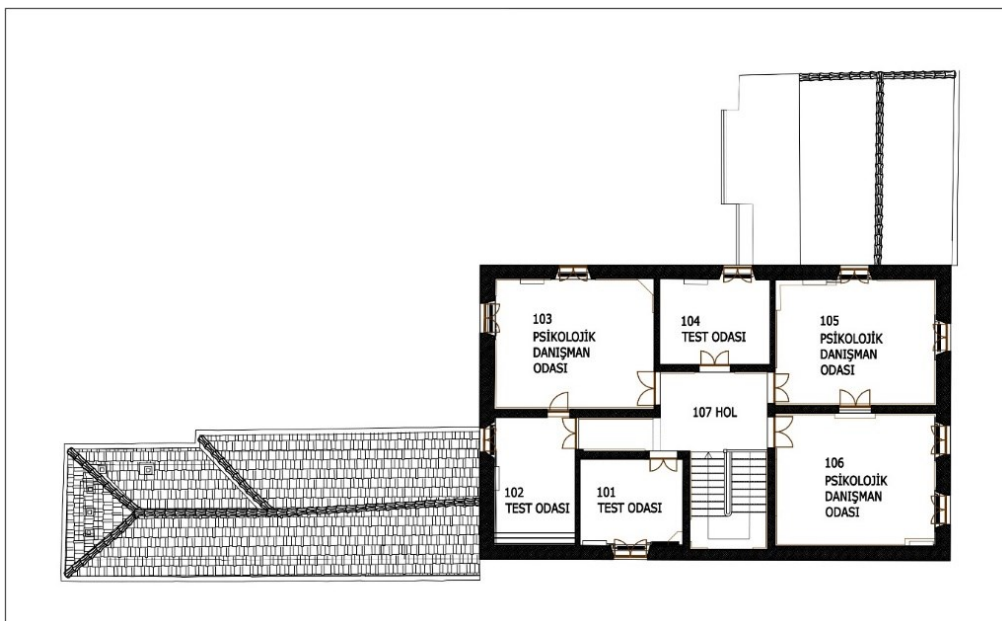
Figure 6. Upper floor plan in measured drawings.

With the wooden planks on the floor, the entrance door with two wings and three panels, and the two windows system: one onto the top of the other, it seems that the originality has been protected well like the other spaces on this floor (Figure. 6). The walls and the ceiling are plastered and painted. There are gypsum mouldings at the ceiling edges.

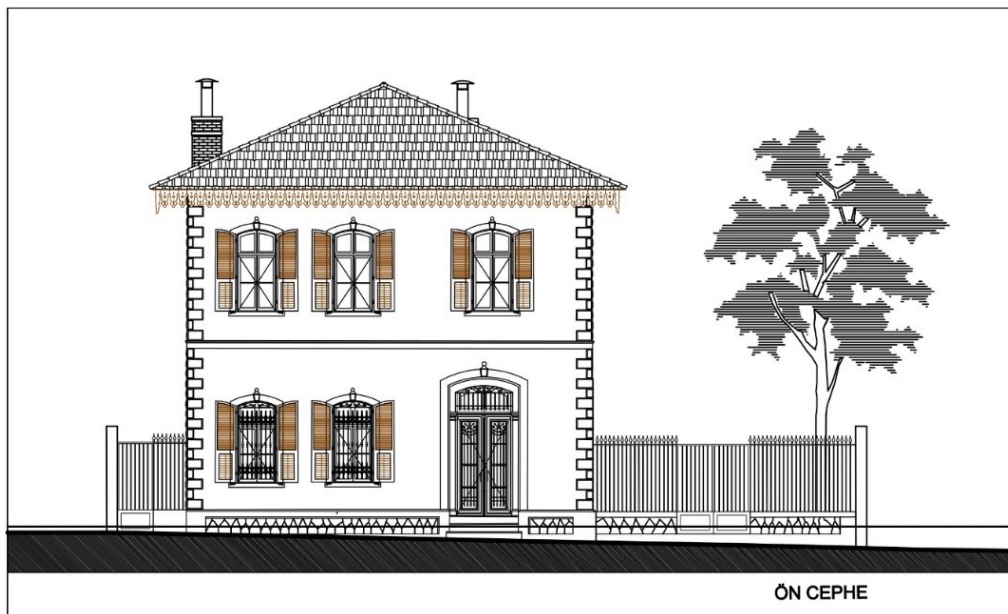
Figure 7. Front elevation of the first period in the restitution project.

It can be mentioned that a gate was existed at the right side of the front elevation to enter the house through the side garden, depending on a photograph from the 1940s (Figure. 7). An iron fence bordering the garden is explicitly seen, where the one-story addition of the 1960s is placed. The gate and the first couple of steps behind, this area was presumably for the guests, welcoming space for the garden parties. On the other hand, the main building is located on the lot with a setback, a short distance from the boundary at its left. Considering the possession limit changes very rarely, it is possible to say that the service entrance might have been here since there is no other option on a narrow and long, row type land allotment. Upper floor windows are with wooden shutters. A chimney in the photograph draws attention. Because it is in the same vertical alignment with the rooms, Z02 and 103, it makes to think whether these two spaces had fireplaces at the time. The front elevation is visually separated into two by a horizontal moulding. A two-winged wrought iron main door is placed within a flat-arched niche with stone jambs. Two windows on the left side of the door and three on the upper floor are also flat-arched and with stone jambs. There are cut stone looking claddings on the corners, keystones at the mid of arches and foliated wooden cornices.
