Non- and Semi-Destructive Assessment Methods Used in Croatia After Recent Earthquakes

*¹ Ph.D. Candidate **Luka Lulić**, ² M.A. **Ana Sušilović** and ³ Dr. **Mislav Stepinac**
University of Zagreb, Faculty of Civil Engineering, Zagreb, Croatia^{1, 2 & 3}

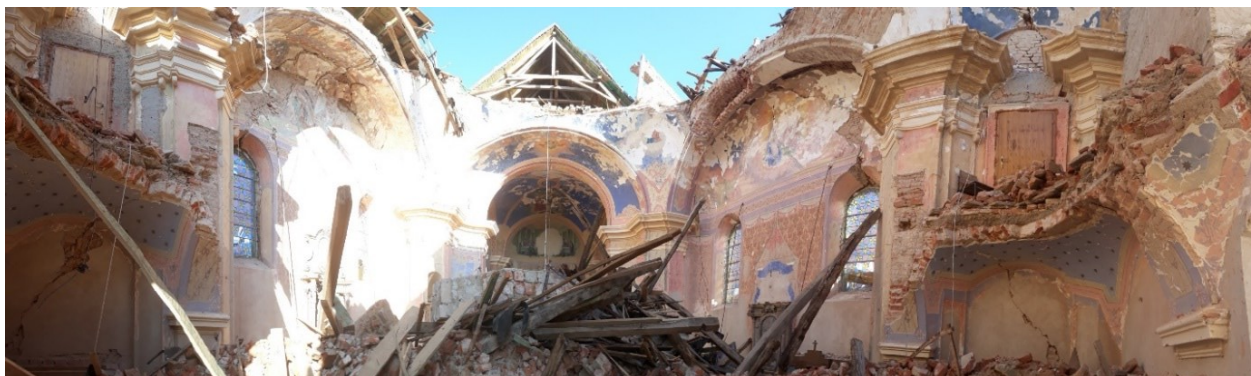
Figure 1. Sacral structure after earthquakes in Croatia

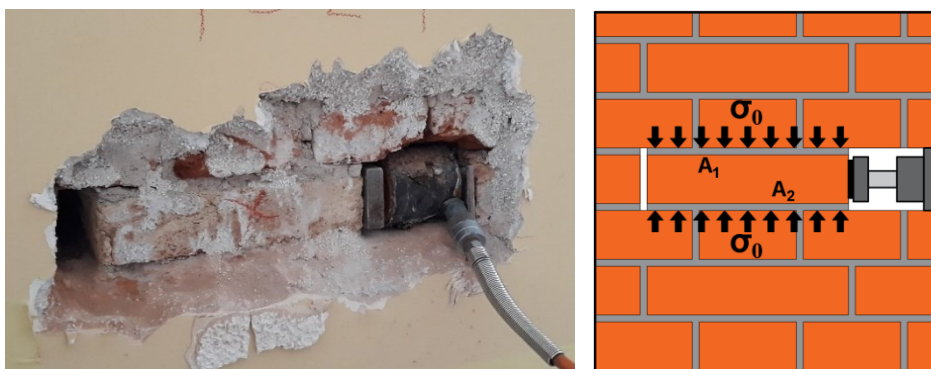
Shear characterization of masonry is undoubtedly one of the most important procedures. Since masonry most often fails in shear, determining shear strength with a high degree of reliability is of great importance. Although the shear test does not reflect the actual shear strength of the entire masonry panel, due to the size effect, it is a good assumption considering that the wall is only slightly damaged in this type of test. Of course, further testing is needed to confirm the claim, but previous tests have shown that the local shear test gives a higher value for shear strength than the value obtained from testing the entire masonry panel (ASTM, 2003). An undamaged brick is selected for the test, and its longer side must be parallel to the wall. For this reason, the test cannot be performed on a wall with a header bond or on an irregular wall. Then openings are made in front of the brick for a small hydraulic jack and behind the brick to have room for movement. The resulting shear strength is the force in the hydraulic jack at the time of brick failure divided by the corresponding areas $A_1 + A_2$. The advantage of this test is that little damage is done to the walls, it is a relatively quick test, and a larger number of tests can be performed on the structure. This gives a good representation of the quality of the masonry throughout the structure (Krolo et al., 2021). On the other hand, the disadvantage is that we do not have information about the vertical stress state at the test location. This is very important considering that shear strength depends on vertical stress. Vertical stresses can later be determined analytically by a load analysis or extracted from a numerical model.

Figure 4. Shear test setup
