Conserving / Not Conserving Cultural Heritage by Using

* Dr. Gamze Fahriye Pehlivan¹

Sivas Cumhuriyet University, Faculty of Architecture, Fine Art and Design, Sivas, Turkey¹

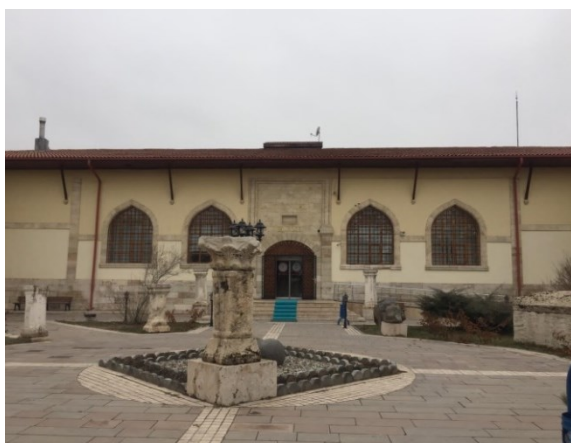
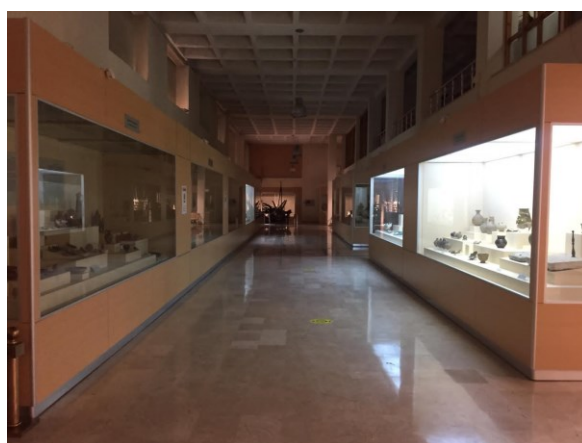
Figure 1. On the left is the Entrance Facade of the Sivas Archaeological Museum, on the right is the Interior of the Museum (22.03.2021).

Sivas Archaeological Museum: The Industrial School, which was built in 1896 and opened in 1902, consists of several buildings. The school had ateliers for carpentry, blacksmithing, carpet weaving, etc. The building which is now an archaeological museum was used as a blacksmithing atelier. According to the inscription on the northern facade, this building was built in 1914 (1332). The building, which was used as Sivas Industrial Vocational High School under the Ministry of National Education until 2003, was later restored to be re-functioned as a museum (Bulut, 2019). It was completed in 2009 and converted into the Sivas Archaeological Museum and continues to function the same way today (Pürlü, 2011; Denizli, 1998). The building has a plan scheme close to plan U, which has small extended rooms from the north and south. The building has wide eaves with wooden buttresses, pointed arched windows and arched doors, mouldings combined with casings, and a hipped roof covered with mission tiles. The plinth level, corners, mouldings and casings of the yellow painted walls are made of smooth cut stone. Ground floor is used as entrance hall, security, exhibition hall, director's room, officers' rooms, teahouse, laboratory, toilet; the basement floor is used as warehouse, toilet, technical space; the upper floor is used as officer rooms, library / archive (Figure 1-2).

In the reuse phase, the mezzanine floor was added to the Sivas Archaeology Museum, and cassette flooring and reinforced concrete columns were made. This application changes the perception of the building for visitors. In terms of interiors, it creates a perception as if you are walking around in a new building. In addition, there are other interventions required by the new function such as plumbing, toilet, kitchen, café.

Although these interventions brought about by the functional change did not affect the aesthetic/ artistic value and technical value of the building, the historical/age value, evidential value and integrity received a score of 4 because they have been affected somewhat. The most affected feature of this building is its authenticity and this criterion has received a score of 3.

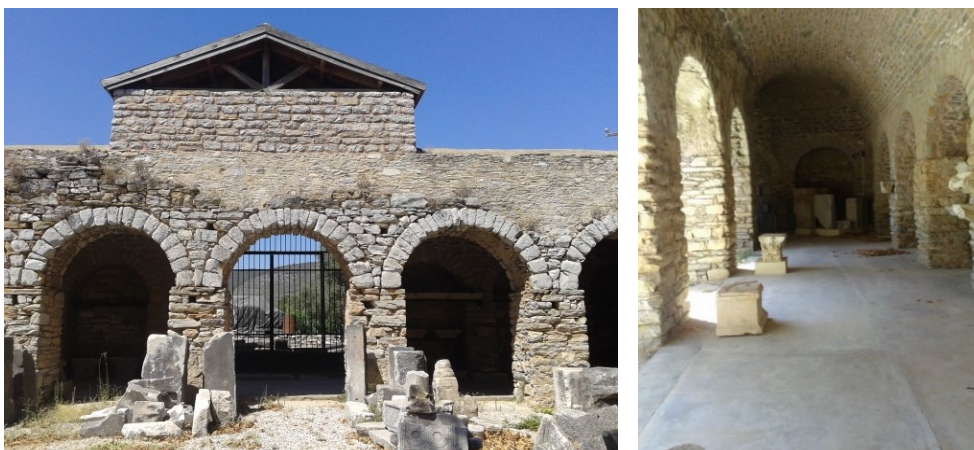
lasos Fish Market Museum: When Italian archaeologists discovered this building in the 20th century; they thought they had found the fish market (macellum) which is mentioned in the book of “Geographika” by Strabon. That's why they called this building "fish market". However, the mausoleum located in the middle of the courtyard of the building gave rise to the idea that it may have been used for another purpose. Yet, today the name of the building is still referred to as the fish market. The function of the building and the date of construction are not fully known; however, the Roman Mausoleum in the middle of the courtyard dates back to the 2nd century AD. The main building, which has a portico plan close to the square, has been used since 1995 as a museum displaying stone artefacts from the Ancient City of lasos (Baldoni, 2004). The building bears the traces of different period restorations. For example, if the masonry is examined, walls are rubble stones in places, pitch-faced stones in places. The vaults are built with raised joints in places. In the restoration, the entrances were raised from the upper elevation of the facade and a wooden gable roof was built on it. The roof is covered with mission tiles. The places where the integration is made are walled with a different material and technique (Figure 3-4).

Figure 4. Photo from the Courtyard of the Fish Market Museum on the Left, Photo from the Exhibition Area on the Right (28.08.2015).

The portico area, which is considered as an exhibition area in the Fish Market Museum, has a vaulted top and plastered with cement. The floor of the exhibition area is concreted. A shelf is mounted on the wall to display some stone artifacts.

In the restoration, the masonry work has changed several times. Since there is no language union in the construction technique, the technical value and aesthetic/ artistic value of the building are somewhat affected. For this reason, it received 4 points. Since there are intensive interventions due to integration, the historical/age value, evidential value, integrity and authenticity of the building were affected and these criteria received 3 points each.

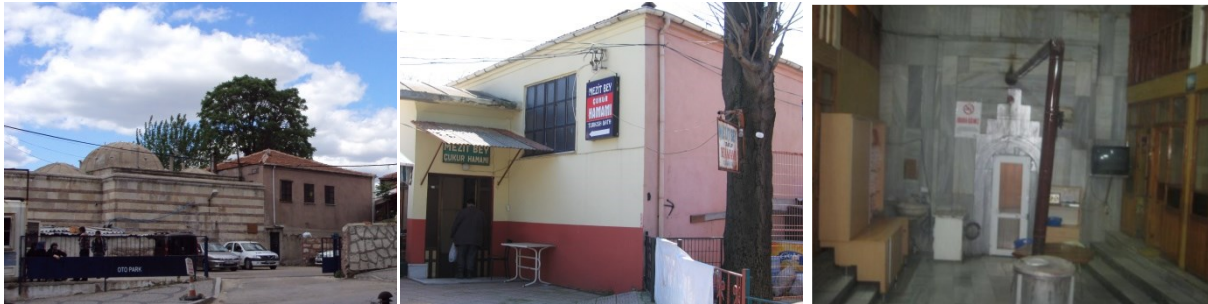
Edirne Mezitbey Çukur Bath: The exact date of the construction of the bathhouse, which was built by Mezit Bey, is not known. Since the period in which Mezit Bey lived was the period of Murad the Second and Mezit Bey was martyred in 1442, it is estimated that the building was built in the early 15th century (Büyükdığın, 1991; Aşut, 2012). It was built as a bathhouse of a complex consisting of a mosque and an imaret (Ayverdi, 1989; Aşut, 2012). The first function of the building was bathhouse and it is still used as a bathhouse today. It was previously owned by the General Directorate of Foundations. Today, the responsibility for maintenance and operation is privately owned. It has a simple plan scheme consisting of changing room, hot room and lukewarm room. The changing room can be accessed through an entrance added afterwards in front of the building. The fact that the walls of the changing room are not at a right angle and that on the plan plane, it overflows at an angle from the axle that forms the outer wall of the bath, suggests that this place may have been built later. This place has 2 floors and the outer walls are made of masonry and plastered, the roof is not made in the form of a dome / vault unlike other spaces, but as a hipped roof (Aşut, 2012). Its windows are in the form of horizontal rectangles, unlike those used in traditional buildings. This reinforces the idea that the place was built later. The interior of this space is completely marble-covered; the space with changing cabins is raised from ground level and made of wood panelling. The spaces, where hot room, lukewarm room, private room and furnace are located, was produced in the almaşık wall technique consisting of smooth cut stone and two rows of bricks (Figure 5-6).

Figure 6. Northwest Wall of Mezitbey Bath on the Left (18.05.2010), Entrance of the Bath in the Middle (18.05.2010), Bath's Changing Room on the Right (Aşut, 2012).

The changing room of Edirne Mezitbey Çukur Bath was built as a 2-storey later and was subject to considerable intervention. Although this place is also the entrance space that welcomes the user, it does not evoke a sense of historical building due to reasons such as the floor that emerged later, the excess of new materials, the use of items / stuffs that are not unique to the original building.

Interventions severely affected the historical/age value, evidential value, aesthetic/ artistic value, technical value, authenticity of the building, thus these values were scored as 2. Integrity criterion scored as 3 because it was affected relatively less than other criteria.
