## Adaptive Reuse of the House of Mirza Mehdi Farrashbashi in Tabriz, Iran

### Abstract

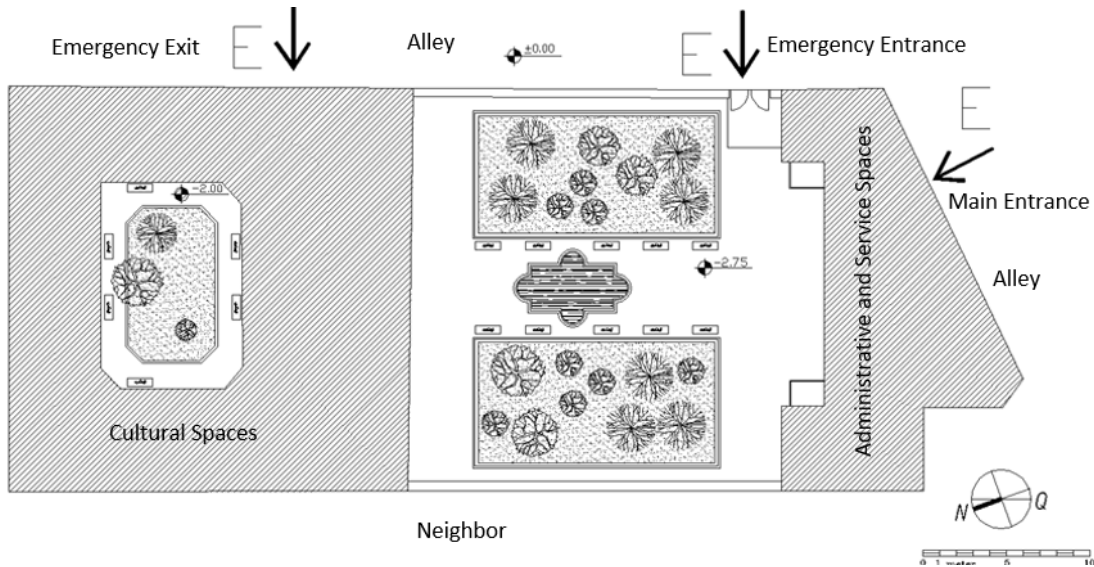
Figure 3. The Designed Site Plan of the Museum of Poets (Asbagh, 2011, P.166).

In this plan, the architectural spaces are divided into three main parts: cultural, administrative and service spaces. Cultural spaces are considered in the Qajarid building and administrative and service spaces are designed in the Pahlavi building. Cultural spaces are consisting of museum, library, and computer site. The museum is divided into two main parts: the museum of the books of the poets, and the museum of the biography of the poets. The original old manuscripts and poetry books of the poets are available in the museum of the books. Moreover, there is a book store for the new editions of the poetry books near the library and museum for sale. The library has reading saloons and bookshelves with librarians to help and guide the readers. There is also a computer site with an assistant and computers connecting to the internet to help the visitors to find the list of the books available in this library easily. They can also have access to the PDF files of these books and listen to the audiobooks of poetry using the computers. Additionally, there is a paper conservation room for the repair of historical books. Administrative spaces are containing the manager’s room, employers’ rooms, secretary’s room, and assistant manager’s room. Service spaces are consisting of a kitchen, security, buffet, traditional teahouse, prayer rooms, and W.C for ladies and gentlemen (Table 2). In general, cultural spaces are located in the Qajar building and office and service spaces are located in the

Pahlavi building (Figure. 3). The Museum of Poets' Biography and the Museum of Poets' Objects are considered on the ground floor of the Qajar building and the library and reading rooms are on the first floor of the Qajar building. Administrative, religious and sanitary spaces are located on the ground floor of the Pahlavi building and a traditional teahouse is located on the first floor of the Pahlavi building (Figure. 4) (Asbagh, 2011, PP.159-160). The structure of the building is currently in a good shape and the lighting of the building especially on the first floor are appropriate for a museum and library (Table 4). The spaces on the ground floor of the Qajarid building need artificial lighting during the day due to the lack of vast windows (Table 3) (Figure. 4 – Figure.6). Traditional brick with mortar is recommended for designing the exterior elevation of the building in horizontal and vertical lines with 90 degrees and 45 degrees (Figure. 5). Transparent tables and desks are suggested for furnishing and neutral colours are better for the flooring (Figure.7). In Table 3 – Table 6 the quality of the spaces in the museum of poets are shown on each floor of the Qajar and Pahlavi building.

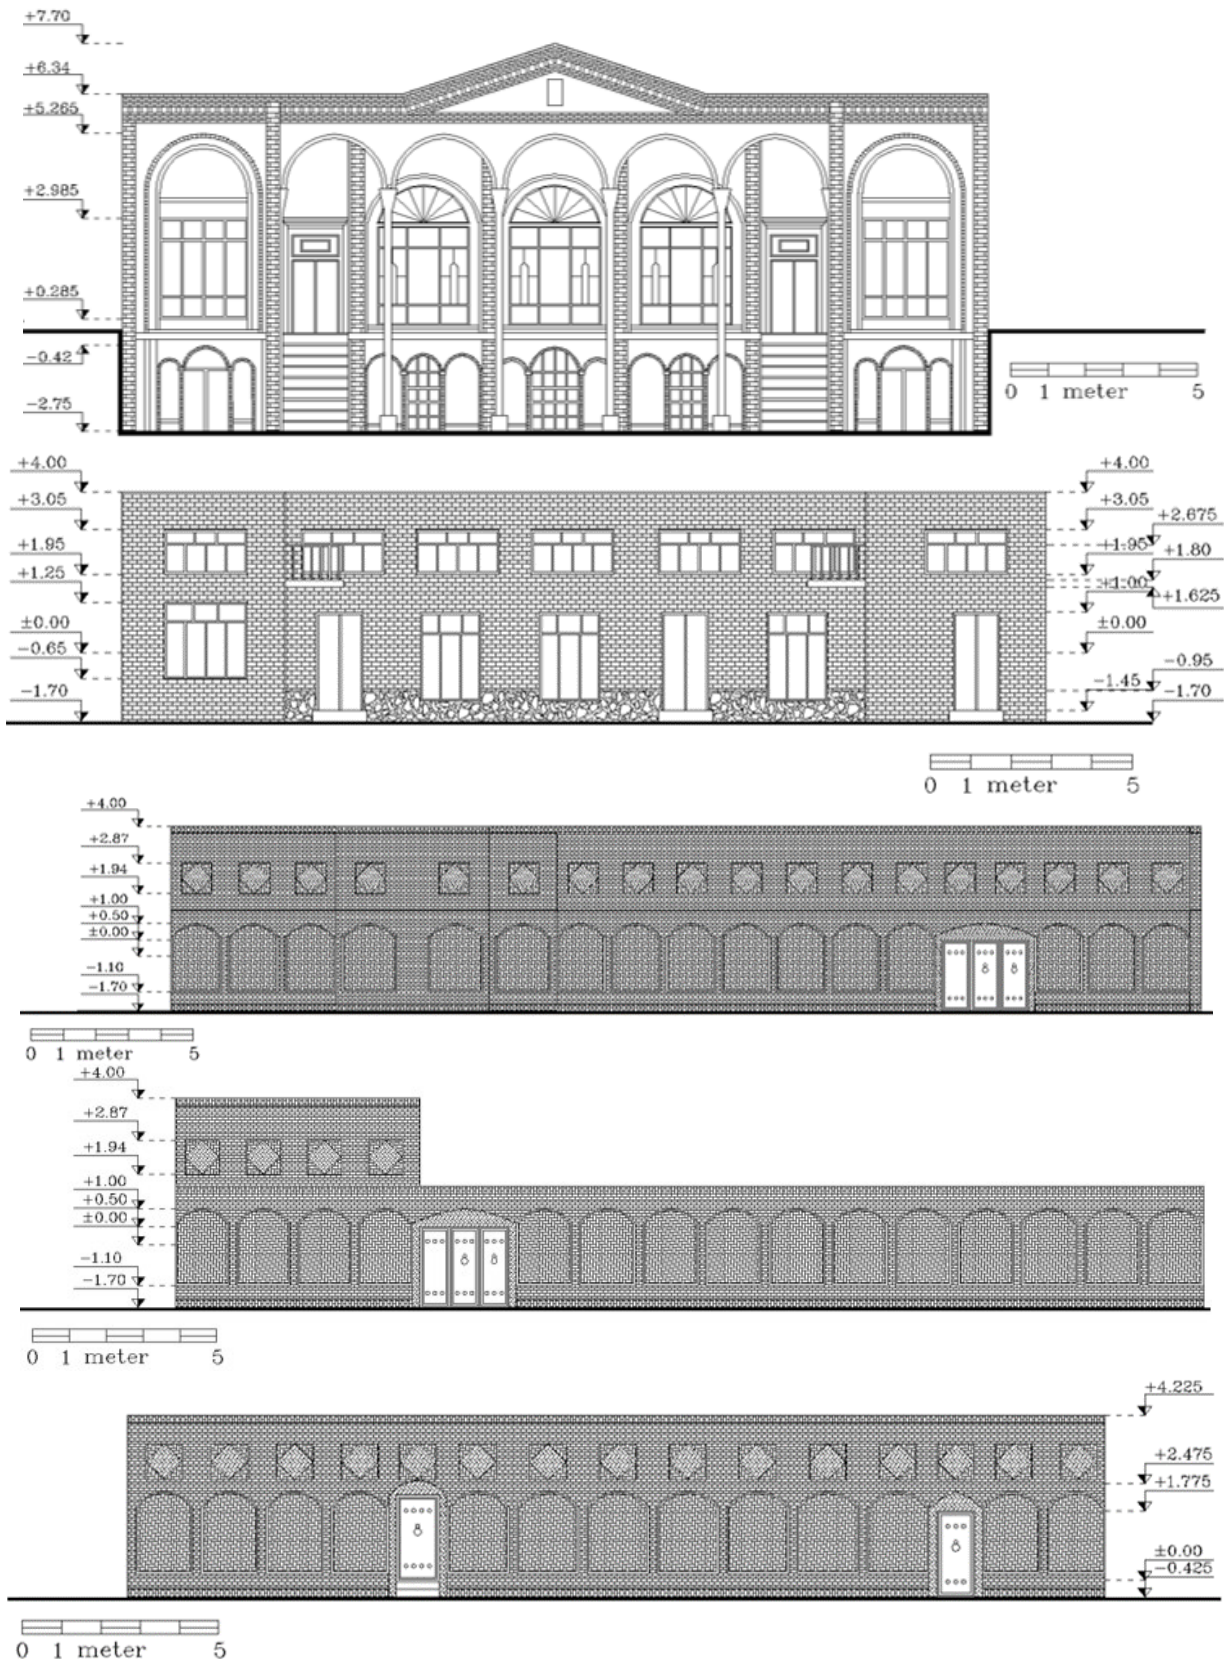
**Figure 5.** The Designed Elevations of the Museum of Poets: (from above to below) The Designed South Elevation of the Qajar Building of the Museum of Poets, The Designed North Elevation of the Pahlavi Building of the Museum of Poets, The Designed South Elevation of the Pahlavi Building of the Museum of Poets, The Designed East Elevation of the Pahlavi Building of the Museum of Poets, and The Designed East Elevation of the Qajar Building of the Museum of Poets (Asbagh, 2011, PP. 143, 145).

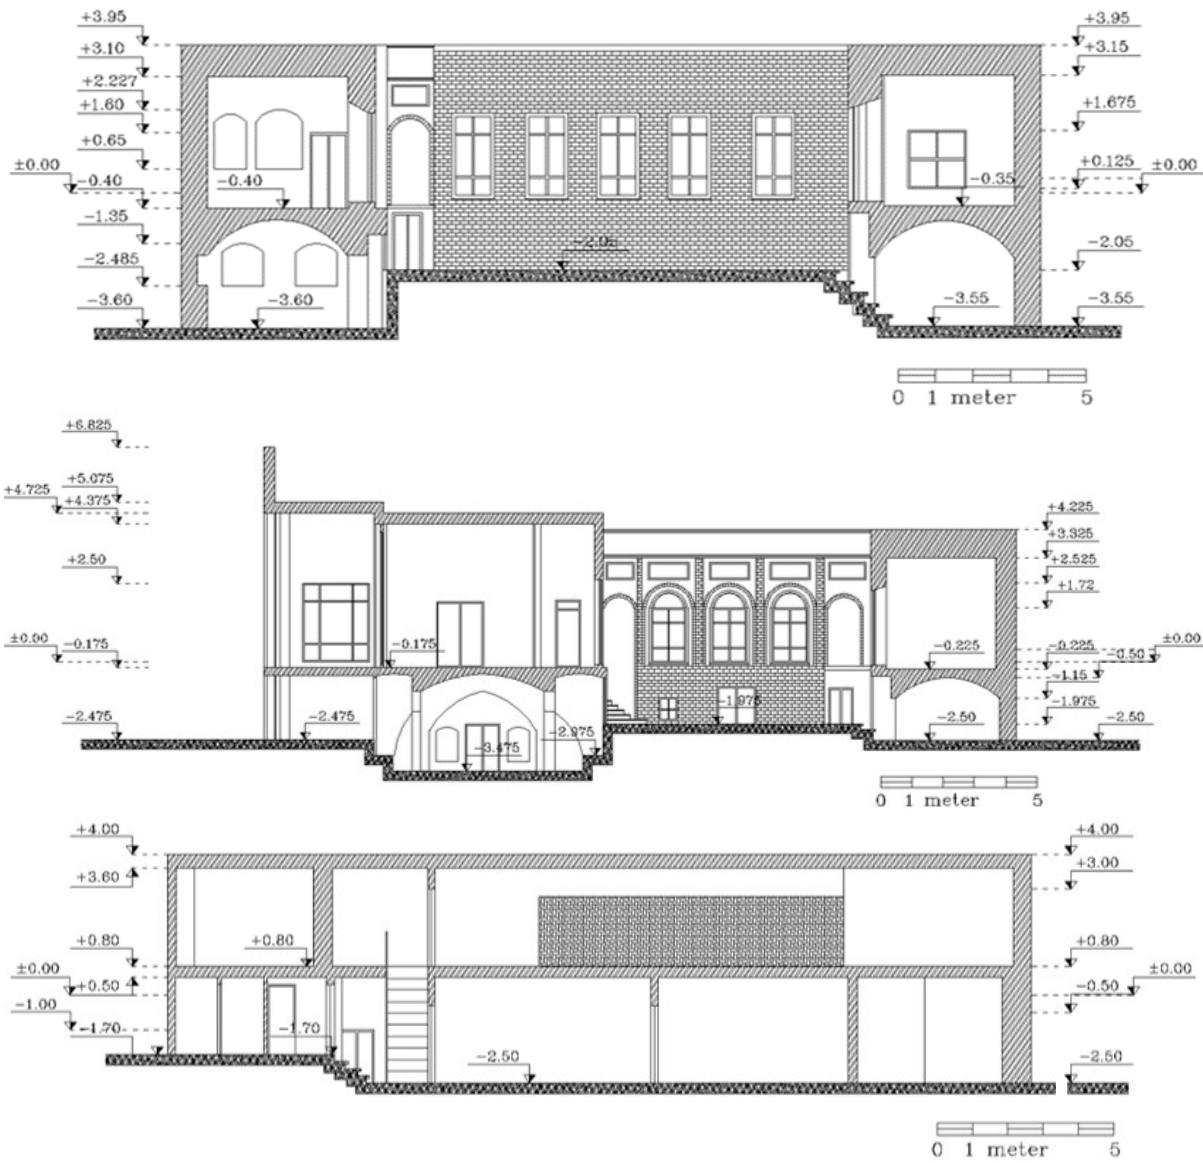
**Figure 6.** The Designed Sections of the Museum of Poets: (from above to below) The Designed A-A Section of the Qajar Building of the Museum of Poets, The Designed B-B Section of the Qajar Building of the Museum of Poets, The Designed C-C Section of the Pahlavi Building of the Museum of Poets (Asbagh, 2011, PP. 145, 146).

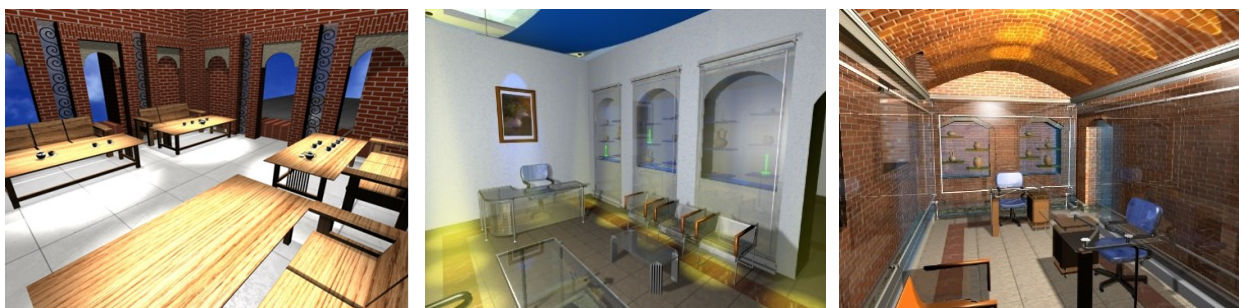
**Figure 7.** The Designed Interior of the Museum of Poets: (from right to left) The Interior of the Traditional Teahouse on the First Floor of the Pahlavi Building of the Museum of Poets, The Interior of the Administrative Room on the Ground Floor of the Pahlavi Building and the Ground Floor of the Qajar Building of the Museum of Poets (Asbagh, 2011, PP.195, 196).
