Arabahmet Neighbourhood: Historical Process and Current Protection, Use and Function Cycle

Abstract

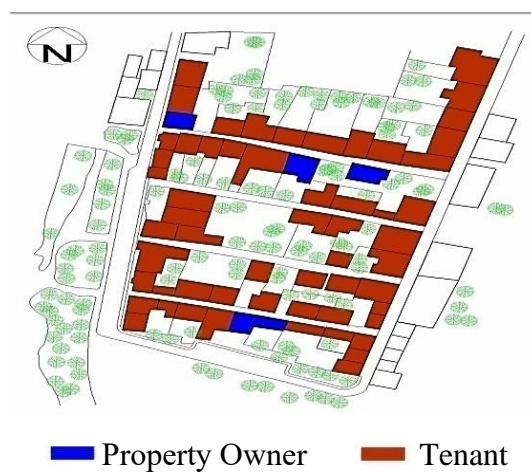
Figure 1.1 Arabahmet Neighbourhood Housing Layout Plan. *Source: Author*

Arabahmet neighbourhood houses are shaped under the influence of natural and cultural factors. Climate conditions, different building materials, topography and economic factors are also affected the shape of the houses. When we look at the neighbourhood texture and organization, the change in the existing texture is observed at first glance, the plan texture of all the houses almost the same however, such as many things that have changed over the years, with the changes of new habitants and their needs it is evident that many things have changed. As a result of the analysis carried out in the neighbourhood, it is seen that while a minority of habitants is property owner, the remaining part is used by the migrants and the poor people. As can be seen in (Figure 1.1)

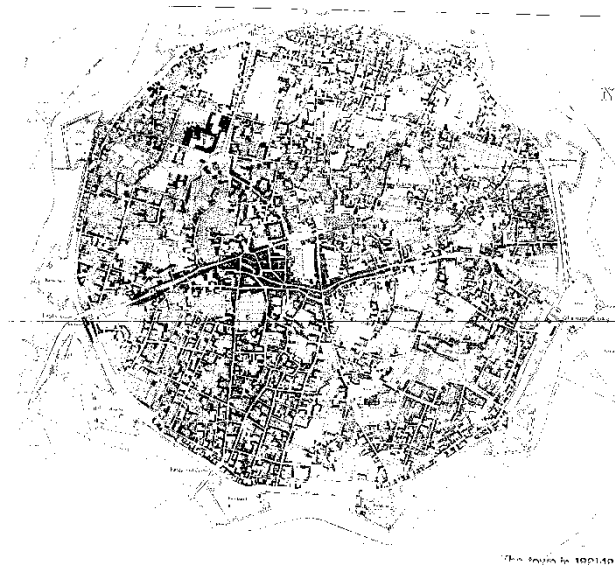
Figure 2. Nicosia City Borders

The City of Nicosia has a circular shape and has traditional streets in the organic structure, which are organized in accordance with the city's form (Figure.2). But as a result of the creation of the buffer zone, many of them have been interrupted, and therefore meaningless and long dead end streets have been formed.

In terms of history and cultural richness, it is observed that the city walls of Nicosia have a circular plan built during the Venetian period. There are 11 bastions on city walls and 3 Venetian gates are designed for entering to the city. The Kyrenia Gate is located in the north, the Paphos Gate is in the west, and the Famagusta Gate is located in the east. Later, 8 more gates were opened with the development of the city out of the walled city (Kahraman, 2008).

There are two main streets (axis) which intersecting at the same time, that divide the Nicosia walled city into four. One of these axes extends from north to south and the other from east to west. The north - south axis extends from Girne Gate to Kara Ismail Bastion, while the east - west axis extends from the Paphos Gate to Famagusta Gate (Zafersoy, Batirbaygil 2014). Cultural, social, public and administrative buildings are located around the intersection of these two axes. Commercial shops and recreational and recreation structures have been found to strengthen and support the extensions of the two axis. There is a residential area in the areas between the axis and the walled city.

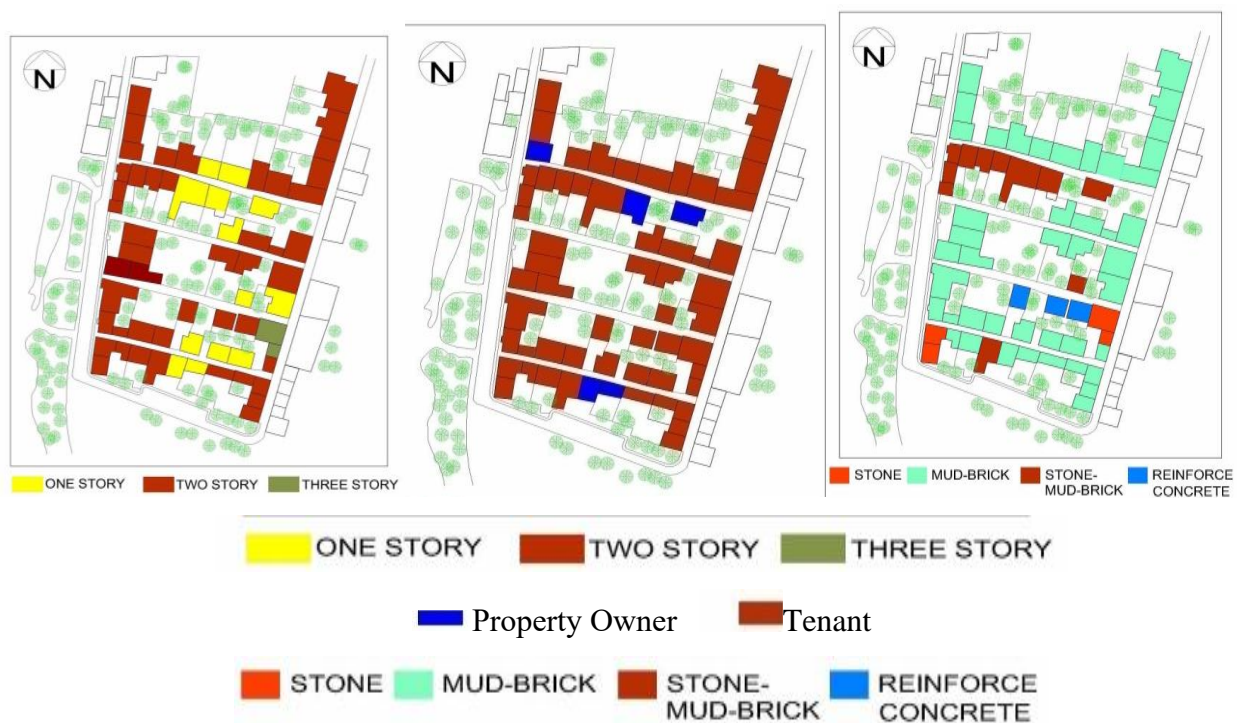
Figure 3.0 Arabahmet Neighbourhood Houses. *Source: Author*

The reflections of the historical heritage structures in which the urban environment in the architectural texture develops and changes rapidly in accordance with today's conditions are shaped by years. Within the scope of the current field study, it is seen that the neighbourhood's traditional structure was preserved in the analysis works carried out on the Arabahmet neighbourhood. Nowadays, this neighbourhood, which reflects the traces of Turkish culture, is known for centuries and has been home to different cultures and they specially bears the traces of Lusignan, Venetian, British and Ottoman periods. In the field study conducted in the neighbourhood, it was found that the houses in this area were single-story, two-story and three-story. While only a minority some of these houses are owned, it is seen that the remaining habitants are tenants whom are immigrants and the economically inadequate people. The building materials of the houses are made with four different type of material. 4 of them stone house, 11 stone and adobe house, 3 concrete, 42 stone brick (Figure 3.0).

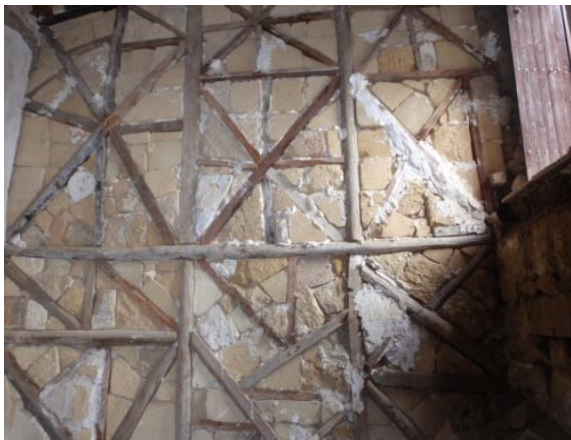
Figure 3.1 Arabahmet Houses' Wall Details.

As a construction system, Nogged system was mostly used in the previous years and especially in the Arabahmet neighbourhood houses, where Ottoman builders were frequently used. This system consisted of two wooden frames and the walls were connected to the each other with the brick nogged system (Figure3.1, Figure3.2.). Both of these systems were connected to the members of the wood and were used extensively in Anatolia and Cyprus during the Ottoman period. The same coating was

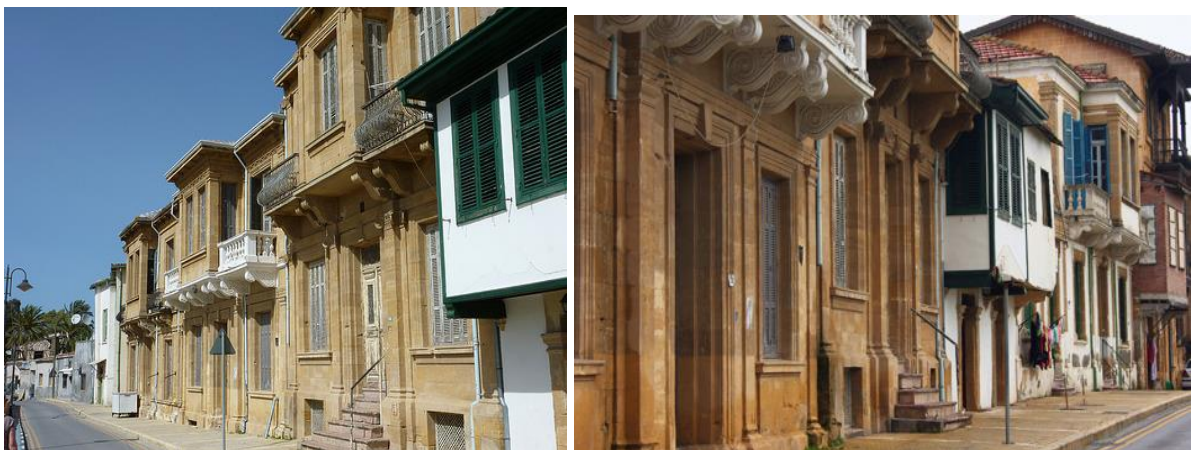
Figure 3.2 Arabahmet Neighbourhood Houses. *Source: Author*

When we look at the neighbourhood in general, it can be seen that small but high-rise windows and facades with bay windows of all houses are arranged to hide inside of the house. And there is a privacy contrast between the inside of the windows and the outside. The arch details, gypsum plasters, bay windows and wooden details on the facades of the houses once again draw attention to the reflections of Ottoman Turkish culture (Figure3.2).

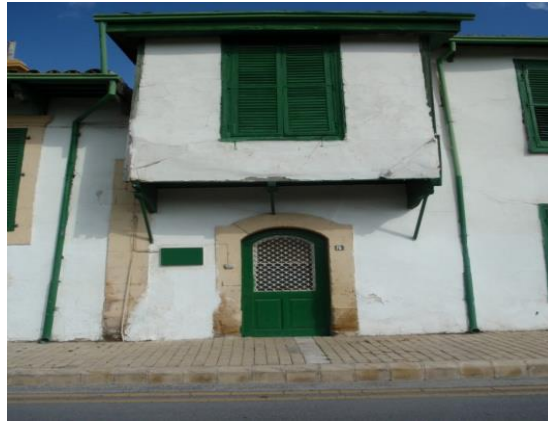
Figure 3.4 Arabahmet Neighbourhood Bay Window Façade. *Source: Author*

Houses on street and street texture cause both visual and perceptual density, but provide a contrast relationship. The houses facing the street in the neighbourhood, as well as the closed fronts, and the front entrance porch houses, adds a distinct mobility to the architectural texture. It is noteworthy that the open and closed houses of this neighbourhood create entirety by fusing different views on the person who sees it. On the other hand upper floors of some houses on the street with bay windows creates a visual rhythm and a relationship between the ground floor and the upper floor and represents the relationship between the first and the second story (Figure3.4). While the narrow streets that resemble a labyrinth in the neighbourhood, which reveals the different perceptions and the emotions

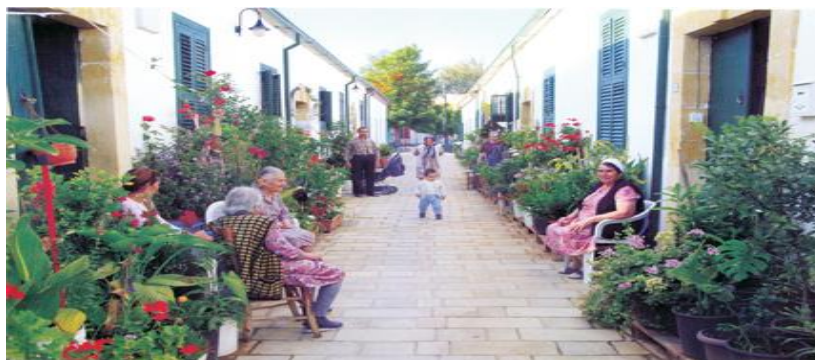
Figure 3.5 Arabahmet Neighbourhood Streets. *Source: Author*

When the reflections of traditional cultural Turkish houses are examined, it is seen that geographic and cultural layers play a major role in the construction of houses. Geographical and cultural branches cause repetition of the spatial character of houses, while also connecting the lifestyle with cultural codes and mutual relations. Between the perceived world and body, it represents the ontological basis of the house, and also can be connected with the cultural layers that reflect the lifestyle of the dialogue between the inner and the outer world, between the visible and the invisible. As seen in Figure 3.5, this scientific relationship is frequently seen in the neighbourhood of Arabahmet.
