Unveiling Urban Vulnerabilities: Analysis of Pedestrian Safety and Experience at 2 No Gate, A Major Arterial Road in Chittagong, Bangladesh

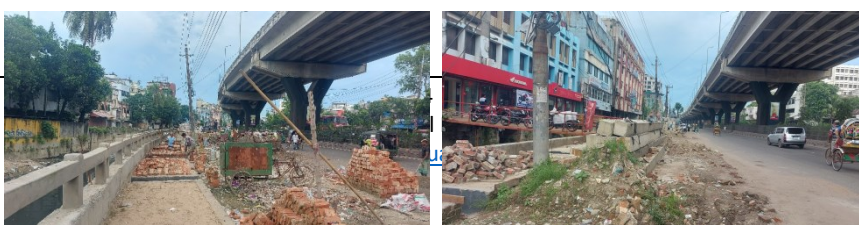
Figure 3: Existing condition of the study area

1. Piling of Garbage on Pedestrian Walkway

The escalating issue of garbage accumulating on pedestrian pathways has become a pressing concern for the community. As refuse continues to mount, pedestrians find their walkways obstructed, causing inconvenience and hazards for those on foot. Frustrated by the impediment, many individuals are reluctantly resorting to using the road for walking, adding an additional layer of risk to their daily commute. Addressing this challenge is essential to ensure safe and accessible public spaces for everyone.

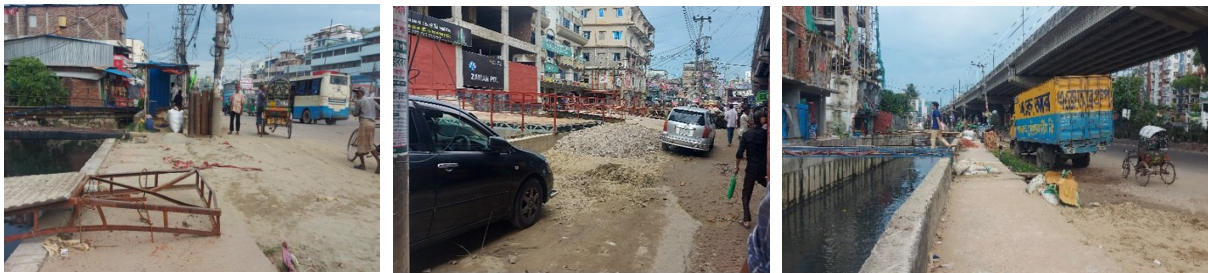
Figure 4: Existing condition of the study area

2. Intrusion on Pedestrian Space

Shops, parking, and various other elements occupy and reduce the available pedestrian space, limiting the areas designated for walking and posing impediments to foot traffic. This encroachment not only diminishes the accessibility of sidewalks and footpaths but also hampers the safety and convenience of pedestrians navigating through these congested areas.

Open Drain Beside of Footpaths and Sidewalks

Dangerous open drains situated alongside footpaths and sidewalks pose a serious hazard to pedestrians. These uncovered channels not only disrupt the smooth flow of pedestrian traffic but also pose a risk of accidents, particularly in low-light conditions or when visibility is poor. Individuals, especially children and the elderly, are vulnerable to falling into these drains, potentially resulting in injuries.

Moreover, the surveyed region reveals evident encroachments on pedestrian pathways, which impede accessibility. Enhancing accessibility necessitates prioritizing pedestrian visibility. Clean, clear and visible pedestrian walkways will greatly improve accessibility. Waterlogging poses a significant concern in the surveyed area, particularly during the monsoon season. Implementing solutions such as porous concrete, permeable pavers, and pervious asphalt can mitigate this issue by allowing rainwater to infiltrate the ground rather than running off into storm drains. These materials help to reduce surface water runoff and lessen the burden on storm-water systems. Rain gardens, bioswales, or vegetated strips alongside sidewalks can capture, filter, and absorb storm-water, reducing the volume of water entering the drainage system. Researches should be conducted to find proper plantation type in the context of Chittagong city’s weather to serve the purpose. The existing open drainage should be covered and buffers should be provided to separate the walking area from the drain during water clogging.

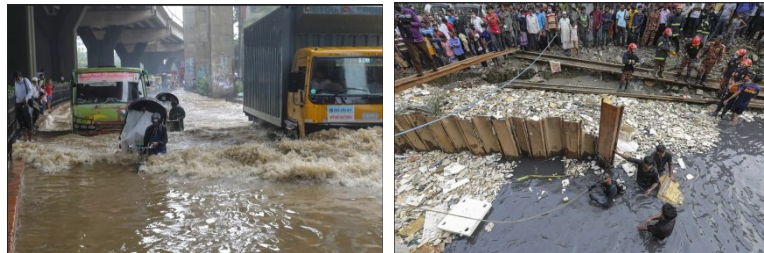
Figure 5: Water clogging during rainy season (Tajmim, 2023)

4. Water Clogging During Monsoon Season

The inadequacy of the drainage system in this region has given rise to a significant issue during the monsoon season, particularly for pedestrians. The accumulation of water has reached a critical level, posing a serious challenge to those on foot. A moderate to heavy rainfall is enough to inundate main roads, lanes and by-lanes with water levels reaching knee-deep. Consequently, the situation has transformed into a hazardous scenario for pedestrians, resembling a potential death trap. The absence of proper drainage covers has led to instances where pedestrians inadvertently fall into uncovered drains, facing catastrophic consequences. In the last two years, six people, including women and children, have drowned due to waterlogging in Chattogram. (Tajmim, 2023)

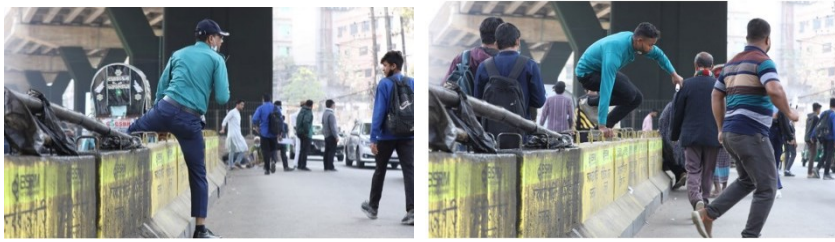
Figure 6: Inadequate road crossing scenario (Jewel, 2022)

5. Inadequate Road Crossing Provision

During the survey availability of pedestrian crossing signs, pedestrian traffic signals and conditions of crosswalk markings have been observed. Due to absence of adequate median barriers allowed pedestrians to cross the road haphazardly instead of using the designated crossing facilities. Moreover, there is only one overpass in the Muradpur junction found in the whole selected area. Unfortunately, the accessibility of this overpass is often hindered by the encroachment of hawkers creating a significant challenge for the pedestrians to cross the road.

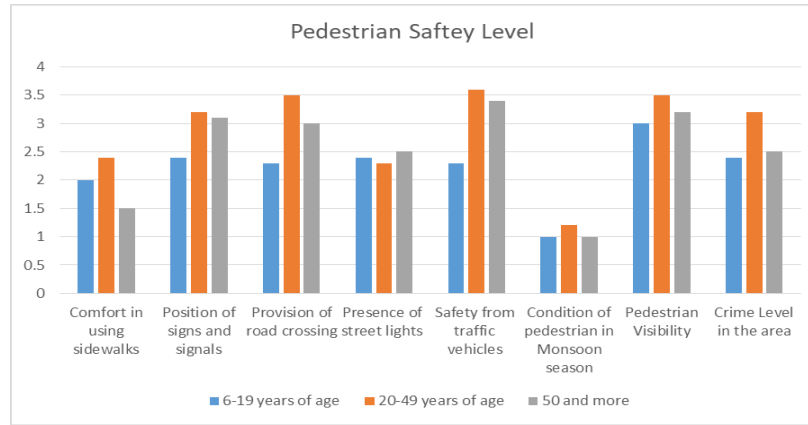
Figure7: Comparing Questionnaire survey analysis for the selected area

Every day, thousands of people of all ages walk through the sidewalks from 2 no. gate to Bohoddarhut circle. People visit the site either for crossing the area, or for transportation, or for their daily activities. Analyzing the results, we find out that the most affected people by the condition of the pedestrian are the elderly ones. The rates given by the different age groups of the targeted population are shown in chart 1. Here, it is seen that the youngsters rate the sidewalk safety category as the lowest. According to this group, pedestrians are not comfortable walking, and especially during monsoon season, they are not safe. It was reported by a 16-year-old school-going boy, "I have to cross the road every day at least two to four times. The road contains heavy traffic vehicles and dust, so it's not convenient to cross the road as I can't see what is appearing in front." It was also reported that even though the crime rate is less in the daytime, oftentimes hijacking occurs at night and dawn, Pick-pocketing occurs in busy hours in the nodes during the daytime also.

The elder group of people, however, faces lesser difficulty in crossing roads, probably because they have experienced the road for a longer time, but the hazards are no different in the rainy seasons. There is also a lack of pedestrian lights, borders on streets, traffic signs and signals, and properly constructed pedestrian walkways which is making the road more difficult to walkability. Thus, it is evident that the surveyed site area is not safe for pedestrians according to the user's perspective. It is regarded as unsafe, or not safe for people of all ages and genders using it on a daily basis.
