Resilience Strategies of Ottoman Architecture between the 15th and 16th Centuries. Case Study of the Restoration of the Columns at the Bardo National Museum in Algiers

1.1 The Bardo, a restoration project

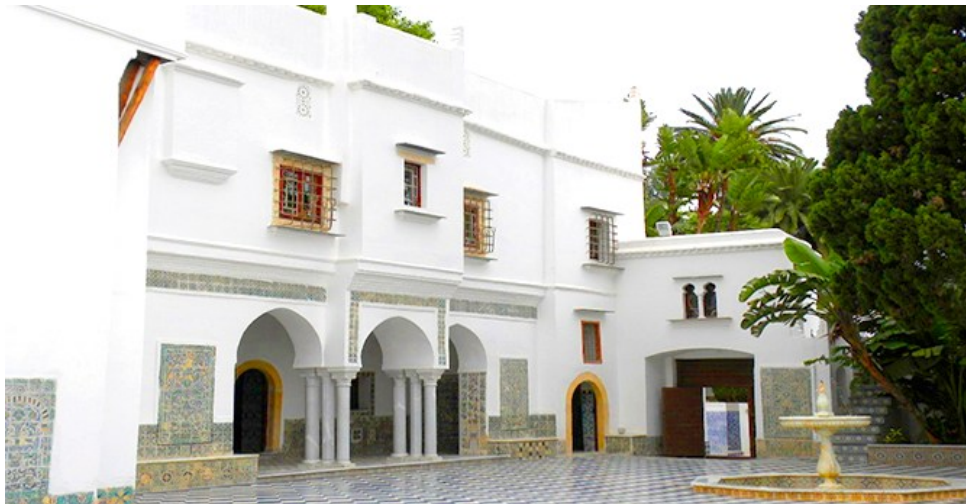
The palace was constructed on two floors (Figure 1), above vast vaulted halls lit by small dormers. The exterior architecture was typical of the traditional Algiers style, with façade offsets and powerful buttresses supporting the tall walls. These featured a few rare rectangular windows, secured by bars. According to E. VALLOIS, 1951: "the Bardo Palace has a vast courtyard, the two entrances face each other, the galleries are arranged according to the same principle. Vegetation is present in reference to the cosmetic paradise, even the ceramic wall coverings of the facades are inspired by the floral register."

Figure 1. The Marble Courtyard (www.museebardo.dz).

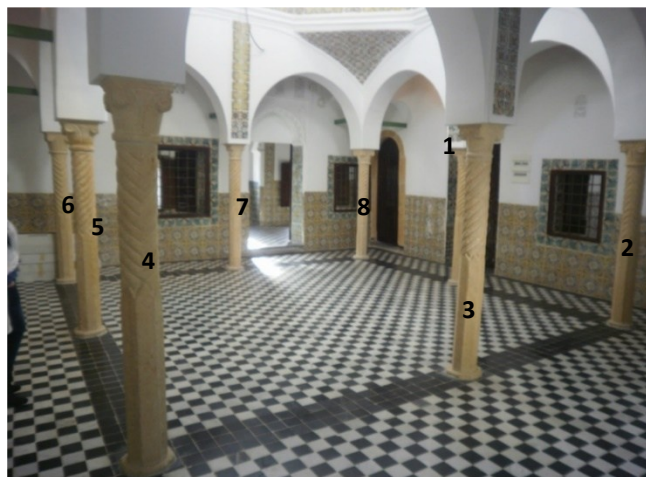
Figure 1. The eight columns of the patio intended for restoration (Bardo Museum, 2012).

The Wast Al-Dar (patio) level is surrounded by eight (08) twisted columns, and semi-twisted columns (Figure 3). This type of column has a low octagonal base that allows the maintenance of the woodwork of the balustrade.

The principle of the treatment is to give the altered superficial part of the stone a cohesion equivalent to that of its unaltered part in depth. The treatment of the patio columns is carried out in situ.

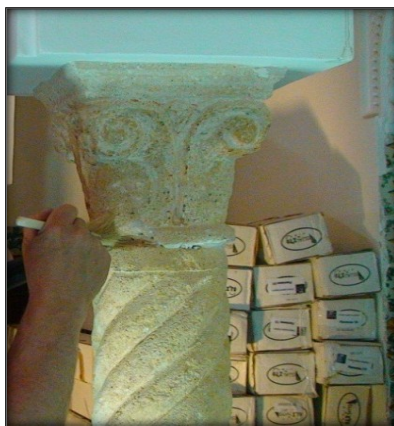
Figure 4. Use of the soft brush and the vacuum cleaner (column 1) (Bardo Museum).

- Brushing using soft brushes made it possible to mechanically remove part of the deposits Image 4.
- Controlled suction complemented this work by capturing the residual particles, without exerting excessive pressure on the stone.

Starting with a dry cleaning type, with soft hair brushes and controlled suction to eliminate surface dust. This initial step was applied to all eight (08) columns taken care of.

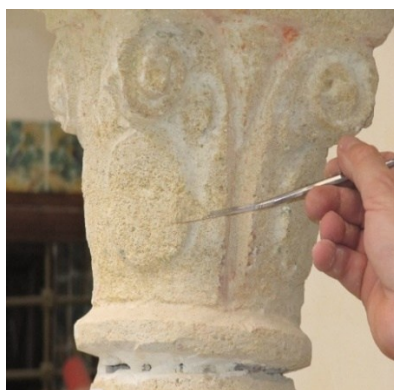
Figure 6. Use of scalpels (column 5).

Steel brushes can only move aside thin layers of dirt and impurities, loosely packed deposits and encrustations. With a soft brush, we move aside, with the deposits, the thin layer of stone to which they are strongly adhered, or we tear them off, revealing the powdery inner parts of the stone. Other instruments are also used to remove concretions and mortar remains on the ceramic support, such as scalpels (Figure 6), vibro-incisors (Figure 7), microtones, fiberglass pencils, etc.

The use of these mechanical cleaning methods has proven effective in deeply cleaning these delicate architectural details in tuff. This made it possible to optimally prepare their surfaces for the following steps of the overall restoration process. This meticulous preparatory phase was therefore essential to ensure the success of the overall restoration of the columns and frames, while preserving their integrity. The expertise and knowledge of the team made it possible to obtain remarkable results at this key stage of the process.

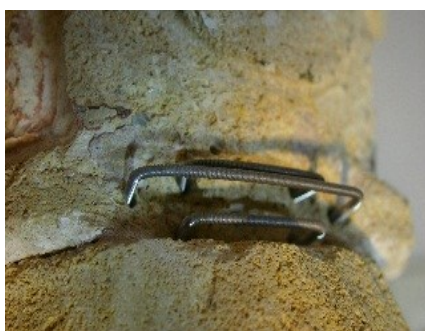
Figure 8. Insertion of stainless steel cores (columns 1-5 and 7).

- The extraction of the eroded part to reach a sound substrate
- The cleaning of the previously well-defined areas to remove the adhering dust
- The insertion, in some cases, of stainless steel cores or fiberglass rods for bonding with an epoxy resin.

The team filled the joint surfaces with lime mortars and then applied an appropriate chromatic treatment, considering the previous interventions to achieve a base color that could be modified later.
