# ICCAUA Proceedings Journal

Proceedings of the international conference of contemporary affairs in architecture and urbanism-ICCAUA  
Volume 9 (December 2026), 2610495

## Seismic Vulnerability of Masonry School Buildings: The Case of Algiers and Blida, Algeria

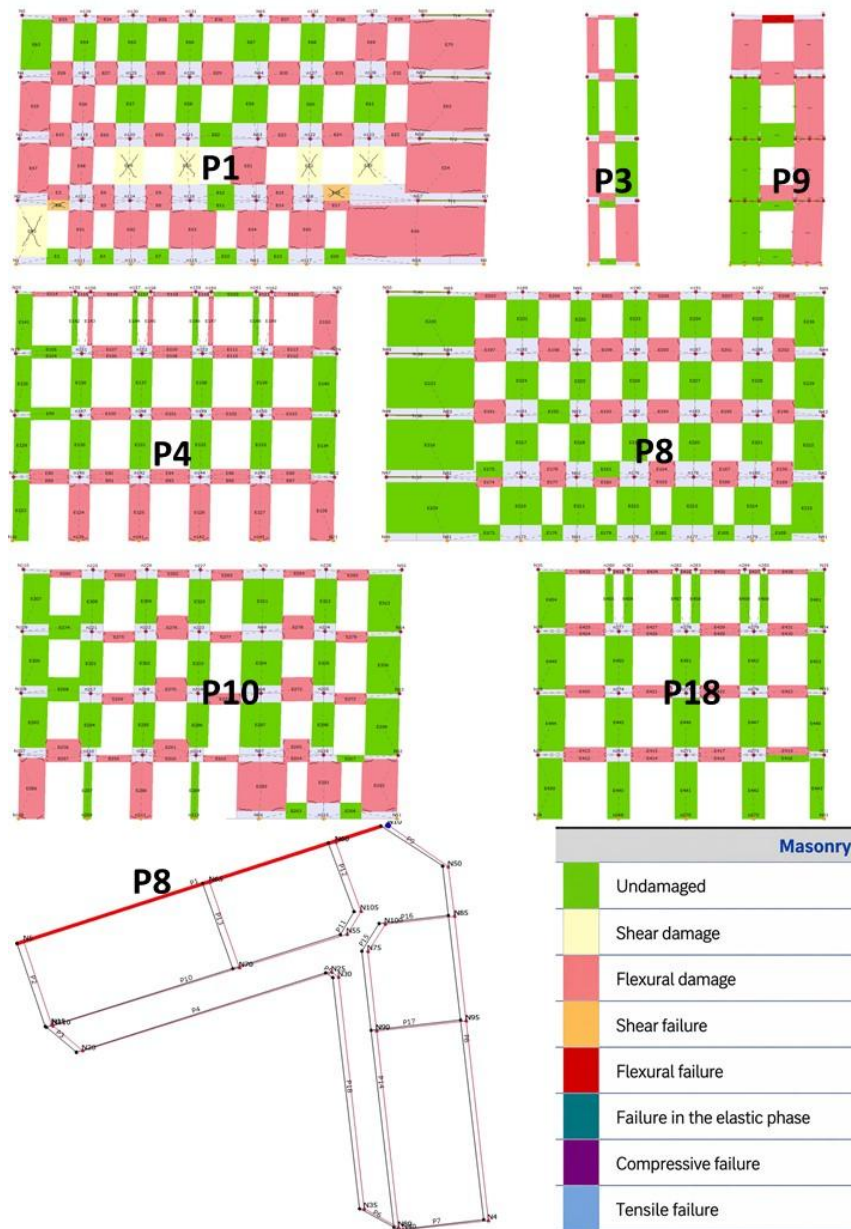
**Figure 8.** Wall damage state of Okba Highschool – Pushover analysis (positive X-direction). Source: (Developed by authors).

The post-pushover damage distribution along the +X direction (Figure 8) reveals a characteristic pattern of damage across the load-bearing wall system. Wall P1 exhibits predominantly flexural damage, concentrated in peripheral zones and at structural junctions, consistent with the bending demand induced by horizontal loading in the +X direction. Wall P3, oriented perpendicularly to the push direction, presents a combined flexural and shear damage pattern, particularly pronounced at the base level.

A significant concentration of damage is observed at the ground floor level of walls P4 and P8, a phenomenon typical of seismic loading conditions where lateral forces — and consequently internal stresses — are generally highest at the base. Wall P8, oriented parallel to the loading direction, exhibits flexural damage primarily at its extremities, while walls P9 and P10, oriented more perpendicularly, display a more complex mixed flexural-shear damage pattern.

The predominance of undamaged zones (green) across the wall system, particularly evident in wall P18, demonstrates that, despite localized damage, a substantial portion of the structure retains its load-bearing capacity. This observation is consistent with the post-elastic deformation capacity identified on the previously analyzed pushover capacity curve. Furthermore, the upper panels of walls P4, P8, and P10 generally sustain less damage than their lower counterparts, reflecting the expected deformation mode of such structural typologies, where lateral displacements increase with height while stress demands remain highest at the base.

The overall damage distribution is consistent with the typical seismic behavior of unreinforced masonry structures under horizontal lateral loading, wherein flexural failure mechanisms predominate in walls oriented parallel to the loading direction — such as P8 — while shear failure mechanisms govern the response of walls oriented perpendicularly — such as P3 and P9.

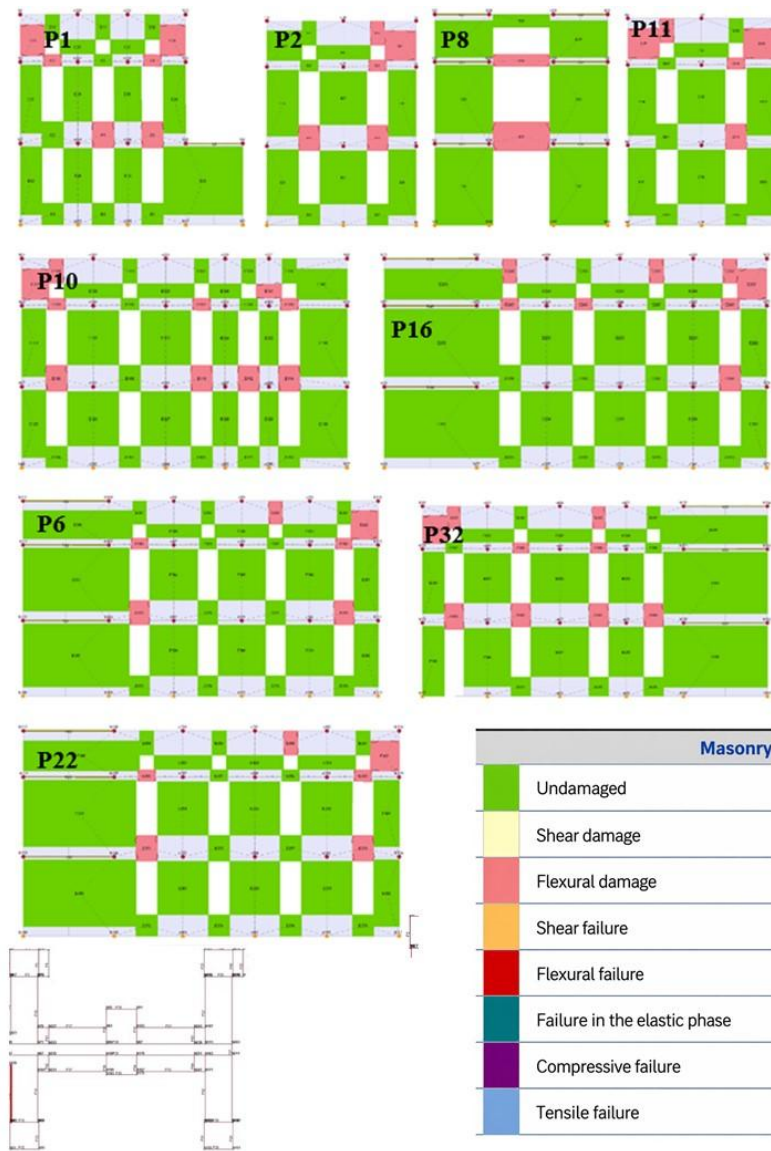
**Figure 12.** Wall damage state of El Feth Highschool – Pushover analysis (positive X-direction). Source: (Developed by authors).

Figure 12 illustrates the in-plan damage distribution across the principal walls of the building following pushover analysis in the +X direction. The predominance of undamaged zones (green) confirms that the structure, characterized by significant lateral stiffness in this direction, has globally performed satisfactorily under the applied horizontal loading demands.

The observed damage is concentrated primarily at the spandrel level, where flexural failure (red zones) and flexural damage (pink zones) are localized predominantly at member extremities. This damage configuration is characteristic of unreinforced masonry buildings, in which spandrels — as the structurally weaker horizontal elements — deform preferentially, thereby dissipating a portion of the seismic energy input and preserving the overall structural integrity.

The piers, as the critical vertical load-bearing members essential to the building's lateral stability, exhibit considerably less damage, with only isolated zones affected by flexural damage. This relative preservation of vertical structural members is favorable to the maintenance of the building's load-bearing capacity under seismic conditions.

The overall damage pattern, largely confined to horizontal non-load-bearing elements (Pilipović et al., 2026), suggests a comparatively satisfactory structural response to lateral loading in the +X direction, notwithstanding the absence of ring beams (tie beams).
