## Restoring Kirkuk Citadel: Unearthing A Ghost Heritage

**Keywords:** Kirkuk Citadel; Heritage conservation; Restoration Plan; Islamic Urbanism; House Typology.

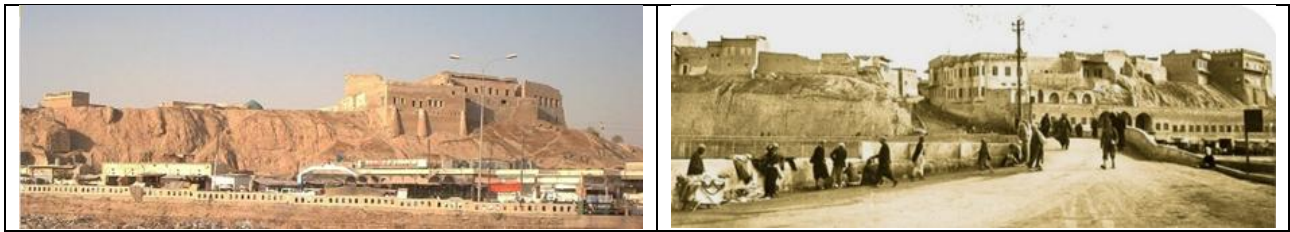
Of the 90 residential structures that once defined the citadel's outer perimeter and architectural character, only four remain standing today. Consequently, the site now presents a diminished appearance, having lost the architectural features that once formed its distinctive and imposing skyline.

**Figure. 1.** Current (left) and former (right) appearance of the citadel's skyline (Source: the author and Kirkuk Heritage Directorate Archive).

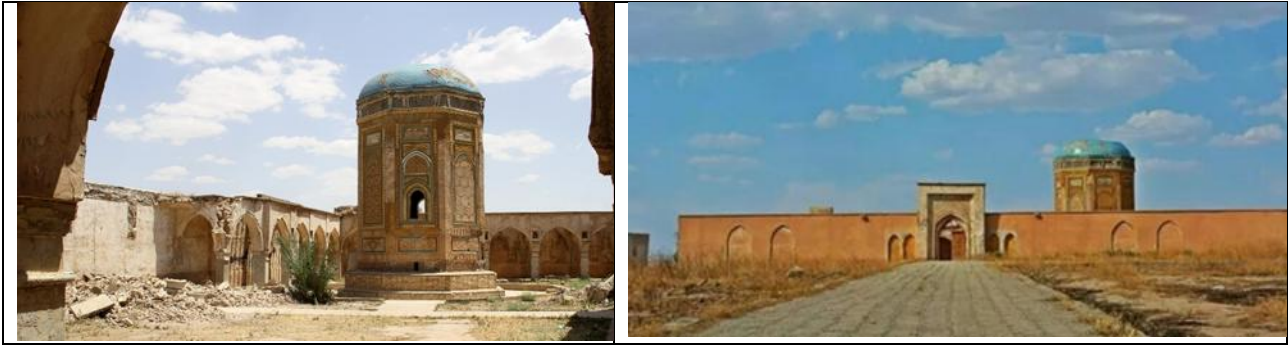
points to an origin during the Ottoman period. The building presents a plain external façade, featuring just two entryways and a small number of windows, while the interior is far more distinctive and richer in architectural detail. It is organized into two parallel rows, each comprising seventeen shops; every unit is fronted by a rounded arch highlighted by a central keystone. Historically, this space served as a vibrant commercial center for trade and the exchange of goods, particularly textiles. Presently, it no longer fulfils a commercial function and is in a fair state of preservation. Nevertheless, following appropriate restoration, it retains significant potential to be revitalized as a key commercial hub for the city. Located in the Maidan district, the “Green Dome” (Qubba al-Khadra) is an octagonal structure dating to the Seljuk-Atabek period (1361 CE), presently in a moderate state of preservation. Its blue-tiled tower rises in two tiers, with robust outer walls adorned with colorful ornamentation and Islamic geometric reliefs. A rectangular precinct surrounds the green-domed building, forming a courtyard enclosure with a large, central framed entrance. The interior façade features stone columns, a series of semicircular arches, and a vaulted passage. Today, the dome and its precinct stand unused, while the vaulted walkway—illustrated in the accompanying figure—suffers from severe structural deterioration.

**Figure 4.** The Green domed tower with vaulted pathway enclosure (Source: Kirkuk Heritage Directorate Archive).

- Restoration is also essential for severely damaged landmarks, including the Green Dome complex, the Caravanserai (Textile Bazaar), Hassan Bakiz Mosque, Al-Arian Mosque, and the Church of Our Lady of Sorrows. Works should also cover all notable residential buildings that are partially or fully decayed — such as

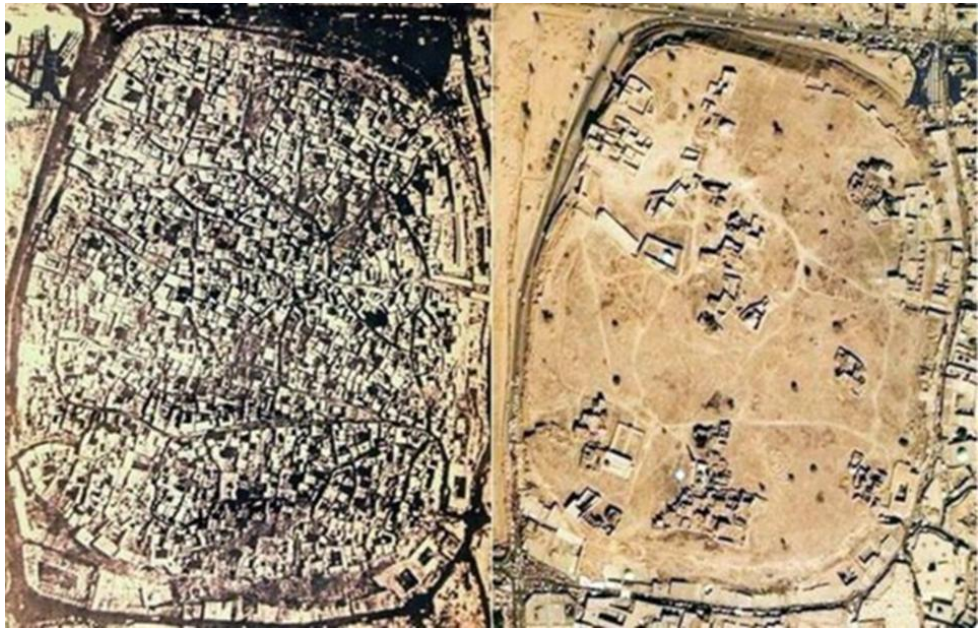
**Figure 6.** The citadel as it appeared before the destruction (left), and following the demolition works of 1997 (right): Source: Duygu S. Mustafa; Sabah Mokhtar; Akar Tuba (2021).

The most drastic intervention occurred from the mid-1990s onwards, when the central government authorized the removal of approximately 93% of the citadel’s-built fabric. Of the original 500 buildings, only 45 were retained. This action was driven by political motives, as the former regime regarded the citadel and its demographic composition as a potential threat to national security

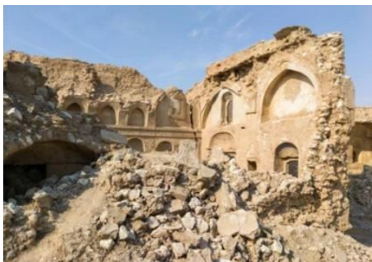
**Figure 7.** The images feature the current structural condition of the citadel’s prominent buildings (Source: Author).

| Remains of a big house with its courtyard filled with debris | The structural condition of "Top Gapi" gate | The remains of Al-Arian Mosque |

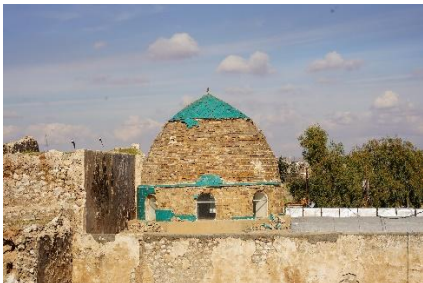
| The structural condition of the great mosque | Remains of the Church of Mother of Sorrow | The green domed tower |

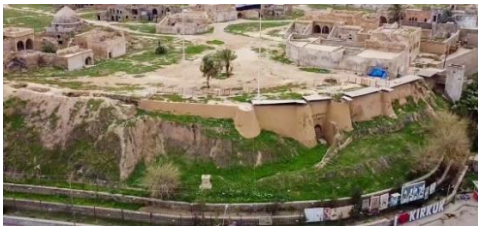
| An Axonometric view of the citadel with its desert-like | Debris on an alley of the citadel | A ruined house in the citadel |
